# Freshwater Introduction South of Highway 82 (ME-16)

## Project Status

## Restoration Strategy

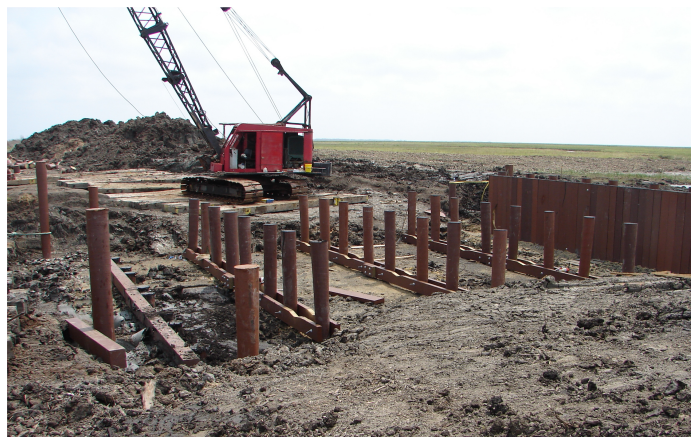
Early stages of the construction of a water control structure to move freshwater to brackish marshes to the south.

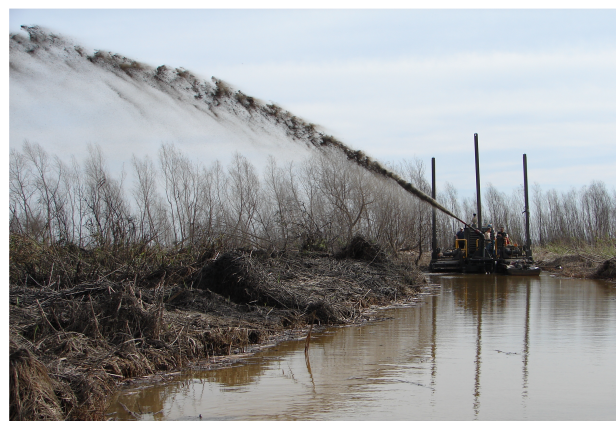
Small spray dredge enlarging the Grand Volle Ditch and spraying the spoil over existing marsh.
